Springfield Township
Montgomery County, Pennsylvania

Walnut Avenue Park

Master Site Development Plan
Stakeholder Meeting 02
February 5, 2025

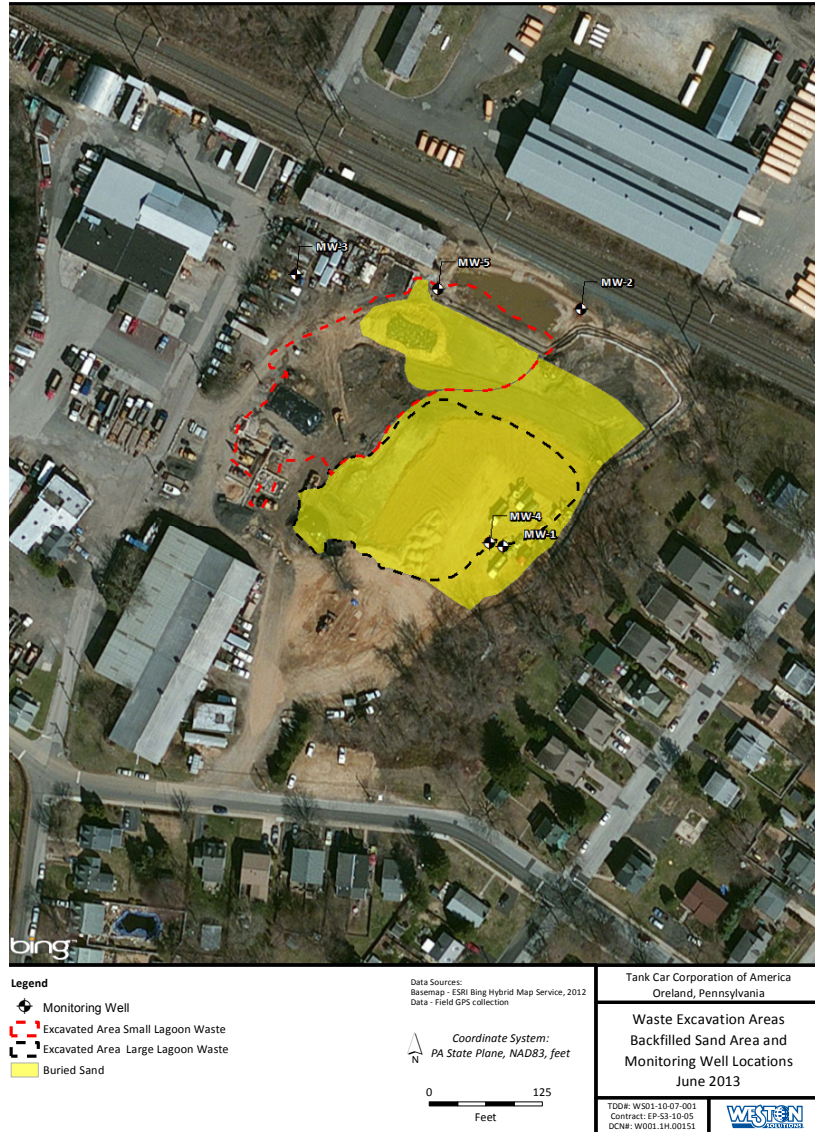
Waste Excavation Areas, Backfilled Sand Area and Monitoring Well Locations by Weston Solutions 06/2013

Remediation Analysis - CAP LOCATION AND GROUNDWATER ELEVATIONS

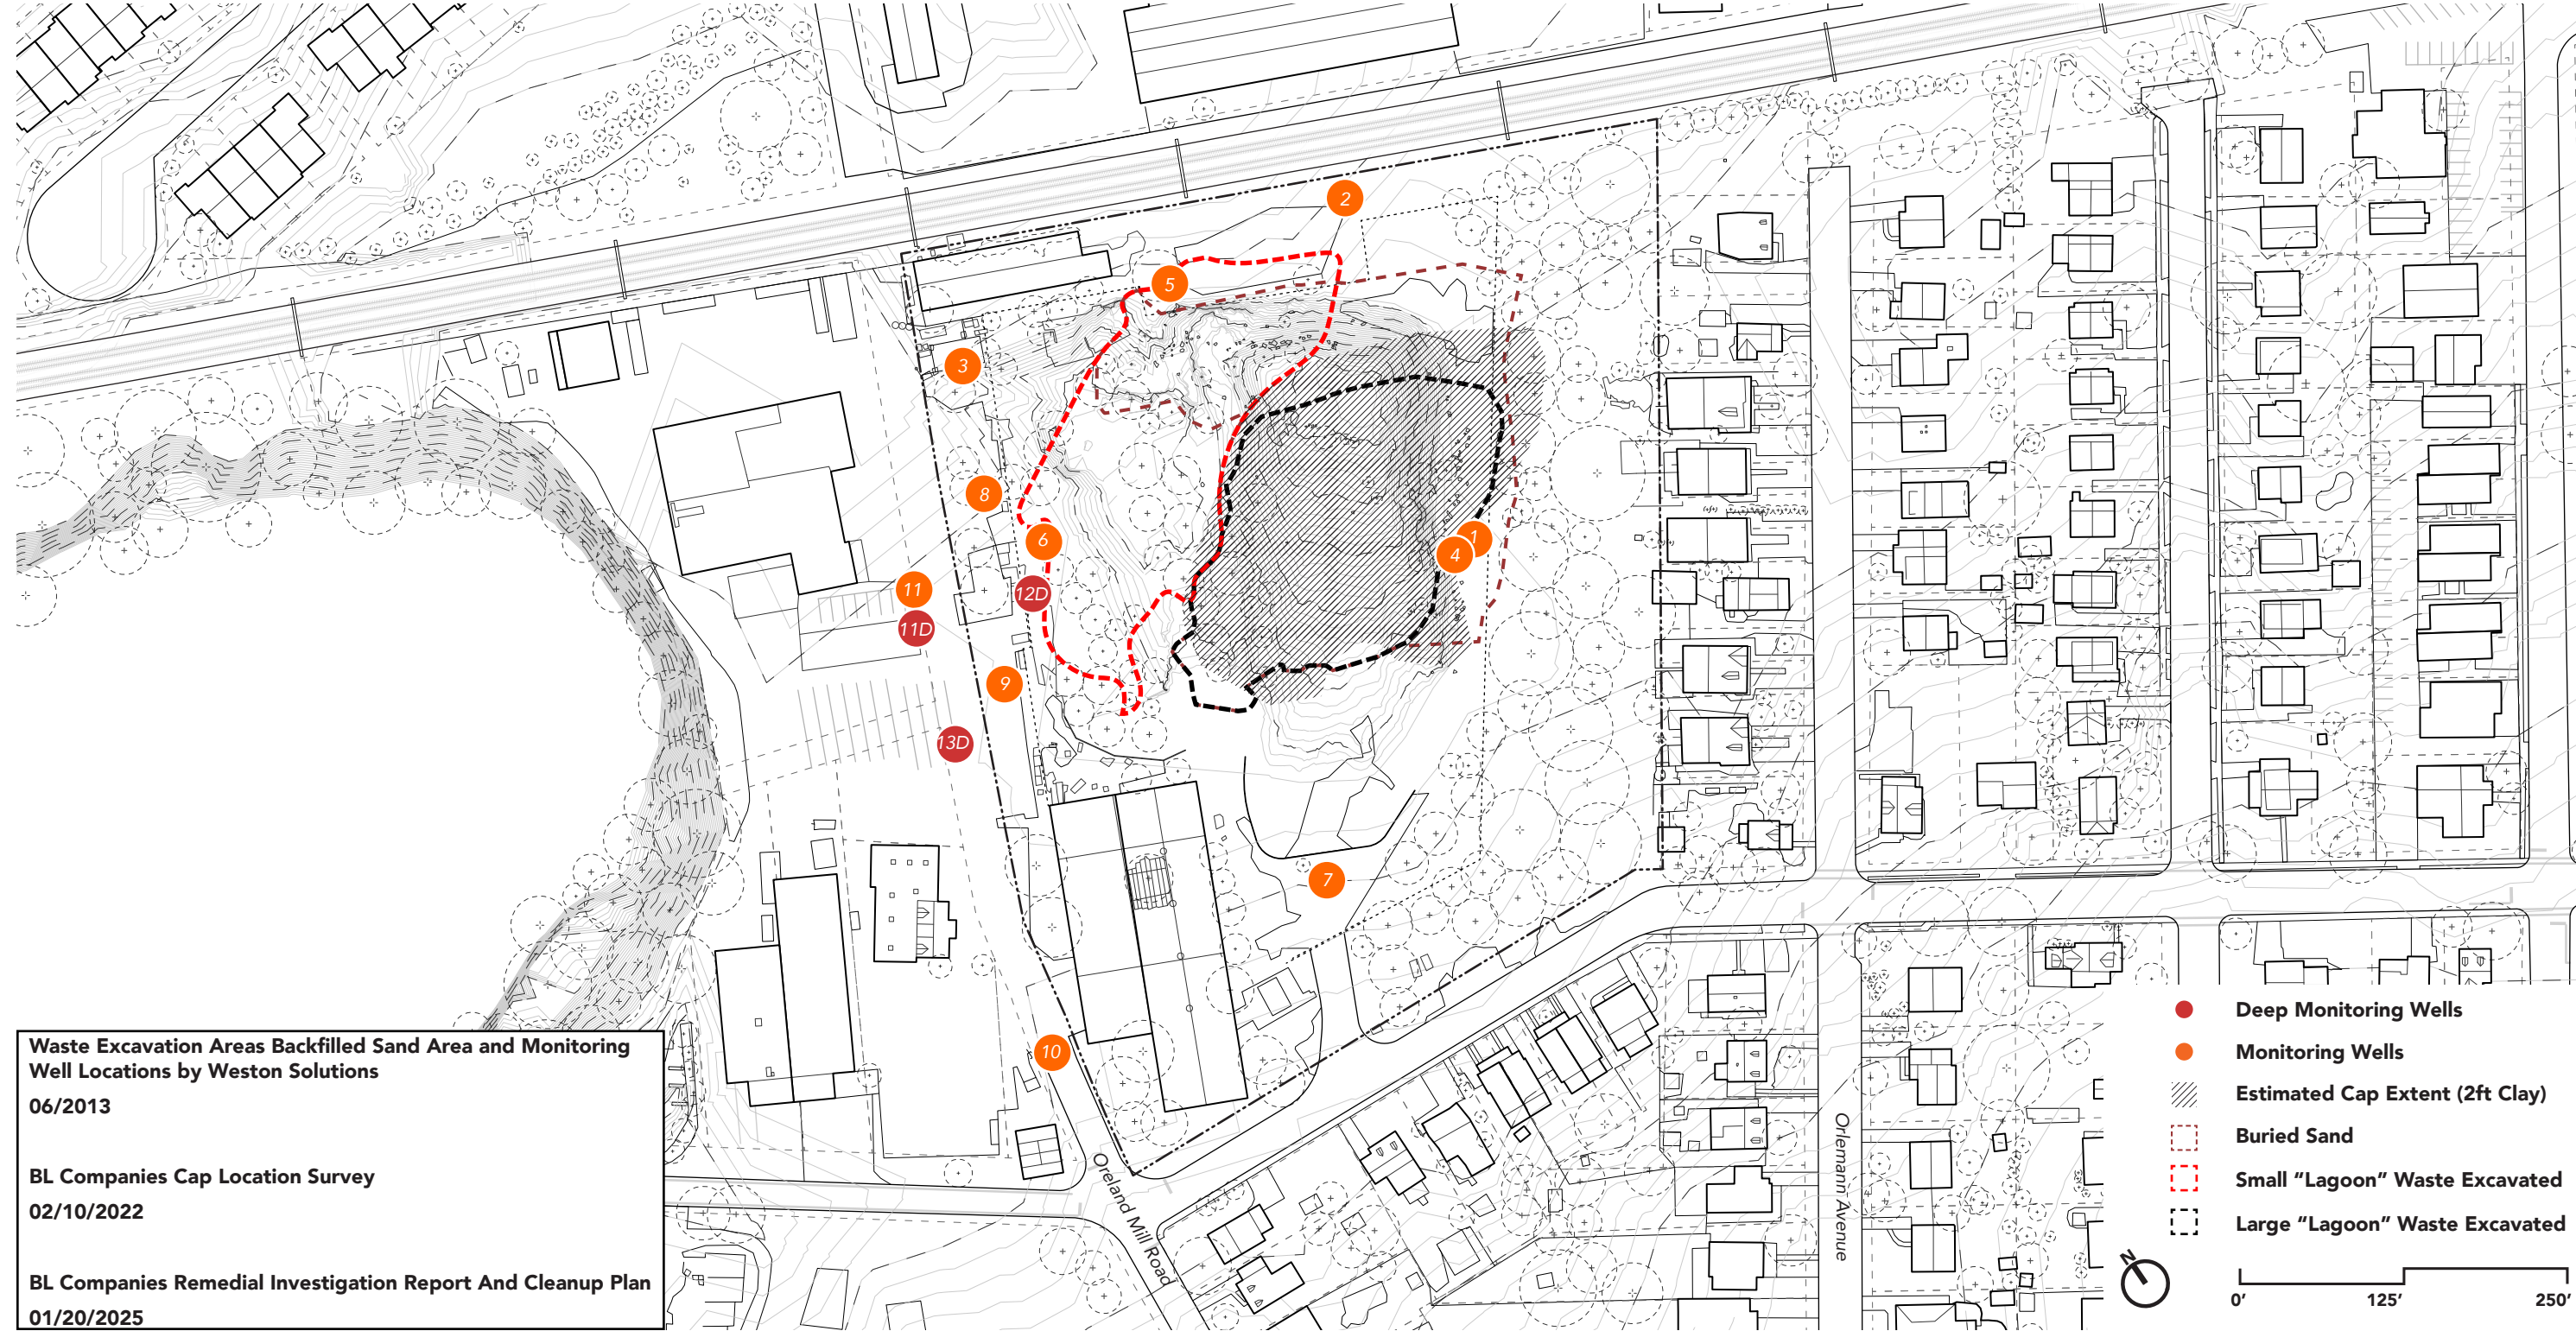
Remediation Analysis - CAP LOCATION

Waste Excavation Areas Backfilled Sand Area and Monitoring Well Locations by Weston Solutions
06/2013

BL Companies Cap Location Survey
02/10/2022

BL Companies Remedial Investigation Report And Cleanup Plan
01/20/2025

- Deep Monitoring Wells
- Monitoring Wells
- ▨ Estimated Cap Extent (2ft Clay)
- - - Buried Sand
- - - Small "Lagoon" Waste Excavated
- - - Large "Lagoon" Waste Excavated

The Remedial Investigation Report and Cleanup Plan (RIR/CP) has determined that there are currently **no direct exposure risks** to the identified contaminants on-site. However, without additional cleanup efforts, these risks could emerge in the future. To prevent this, the Cleanup Plan outlines **specific measures** to eliminate potential exposure pathways and ensure the site remains safe for the community:

- (A) Require the placement of a clean fill soil cap (minimum thickness of two feet) over the entire Site*
- (B) Require future earthwork activities to be conducted in accordance with a soil management plan;*
- (C) Restrict the use of ground water at the Site and periodically ensure that no potable wells have been installed at the western-adjointing properties;*
- (D) Require future inhabitable buildings on the Site to incorporate vapor mitigation measures into the construction designs.*

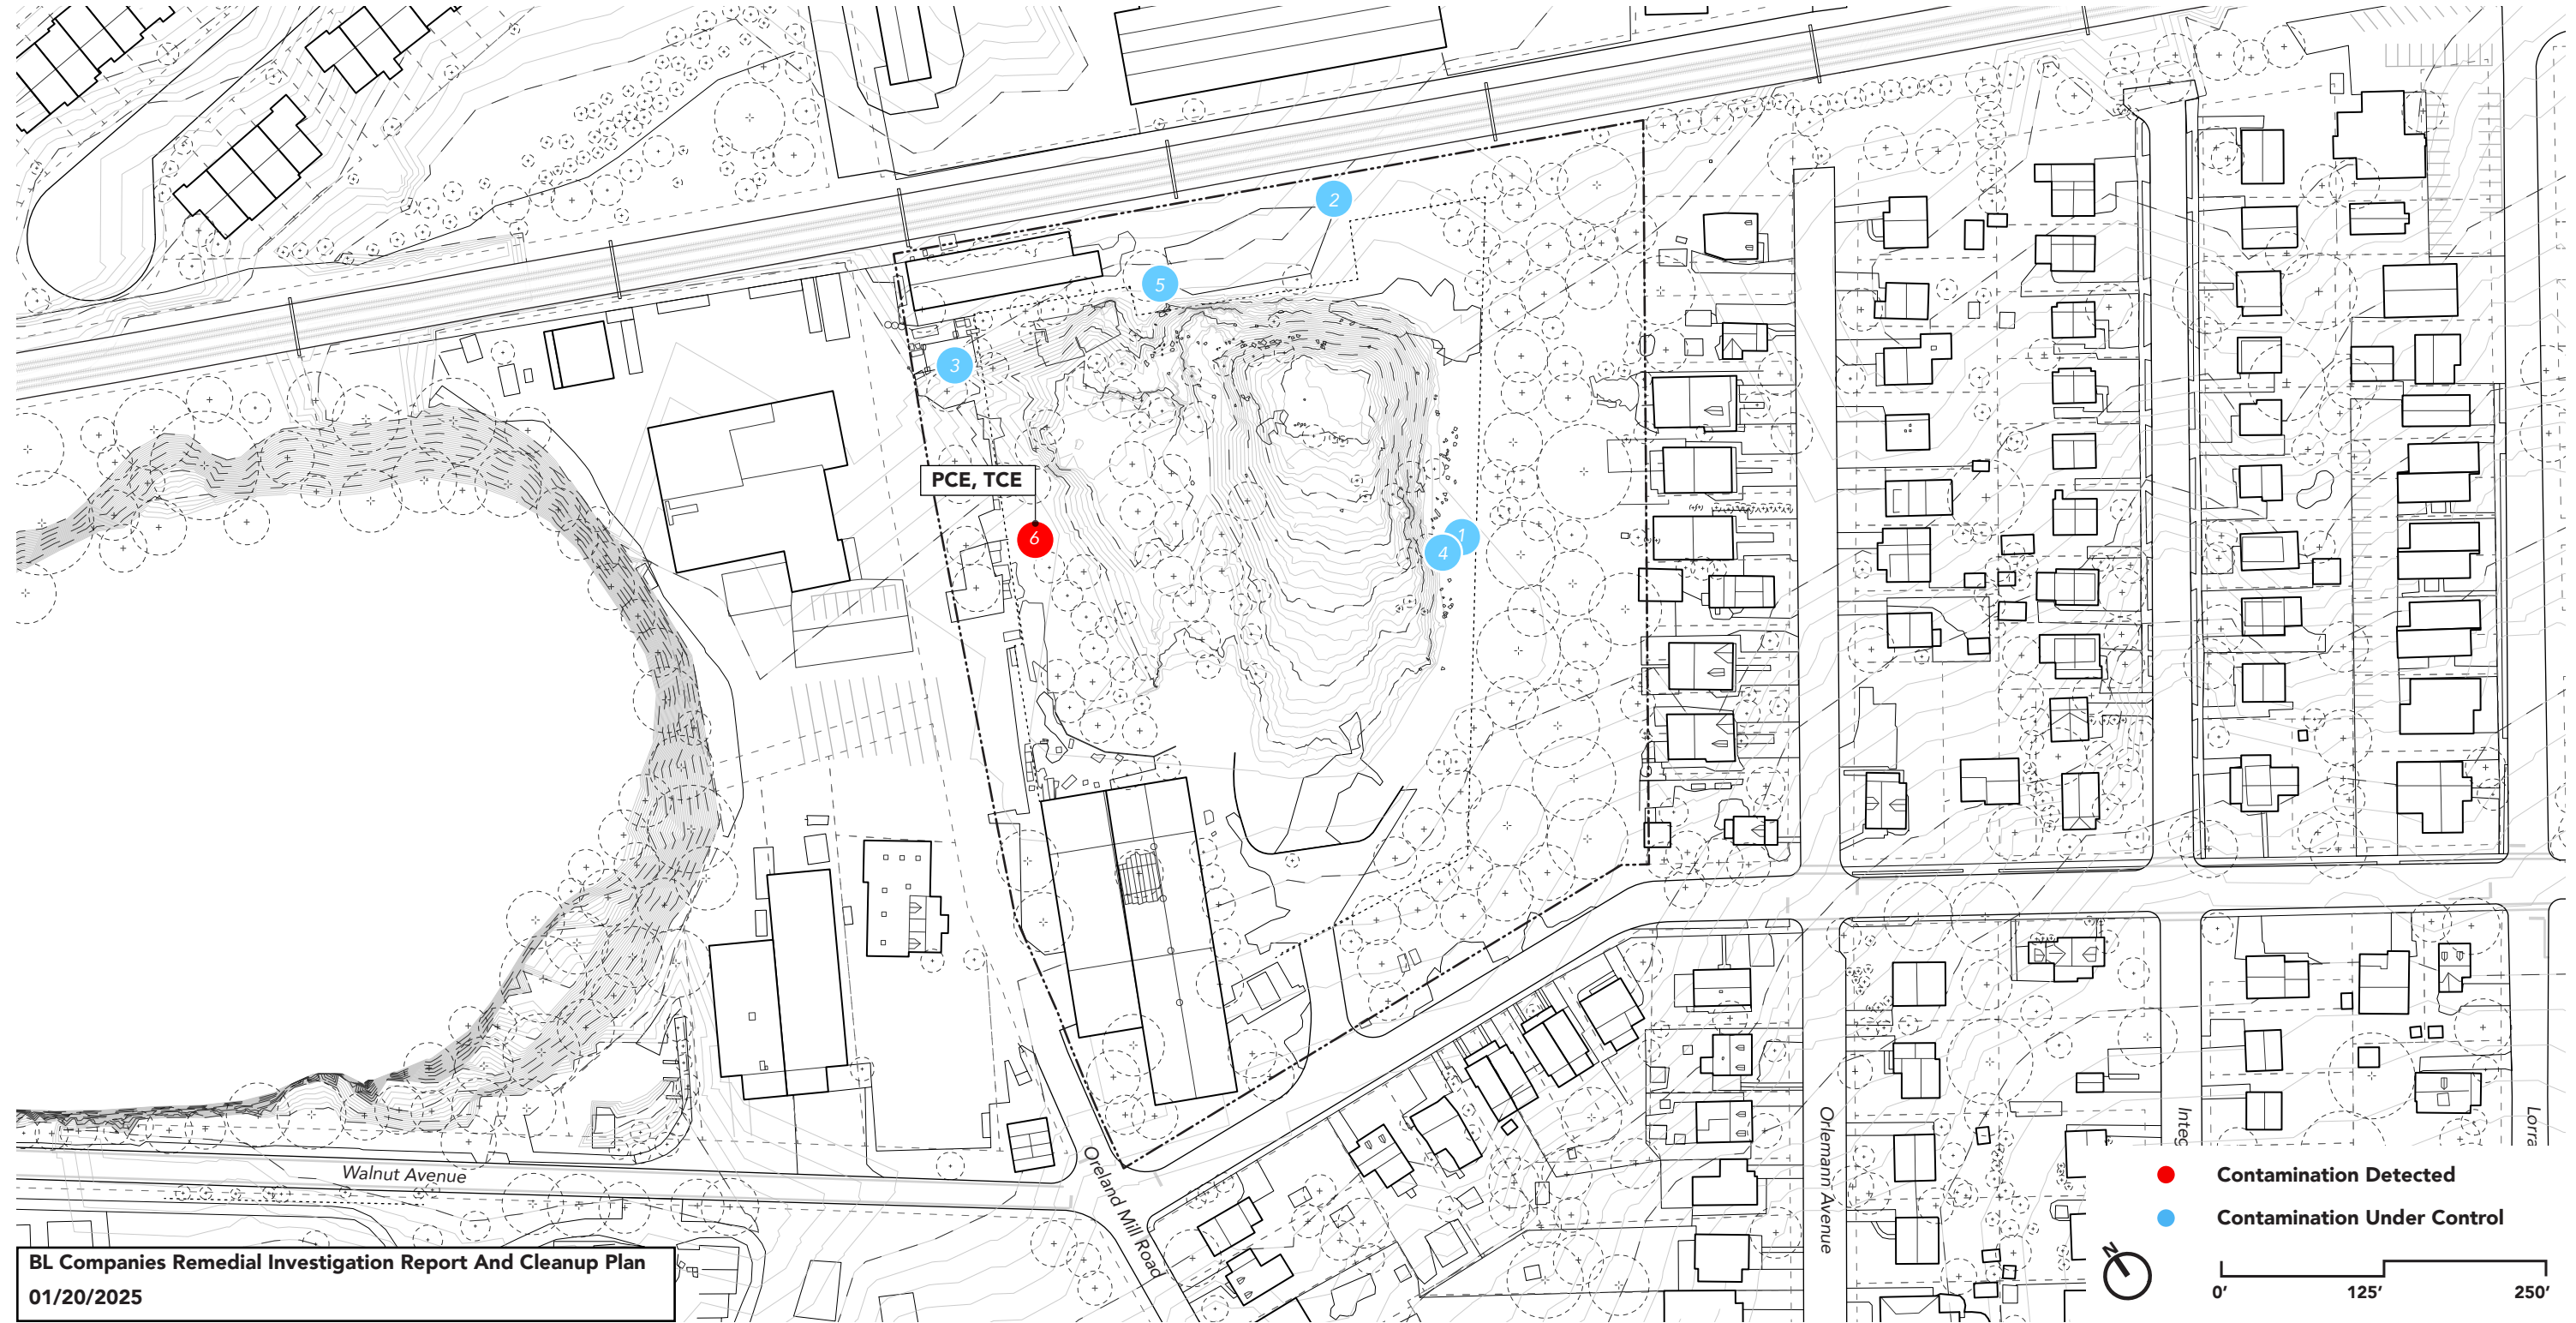
Remediation Analysis - MONITORING WELL AUGUST 2017

BL Companies Remedial Investigation Report And Cleanup Plan
01/20/2025

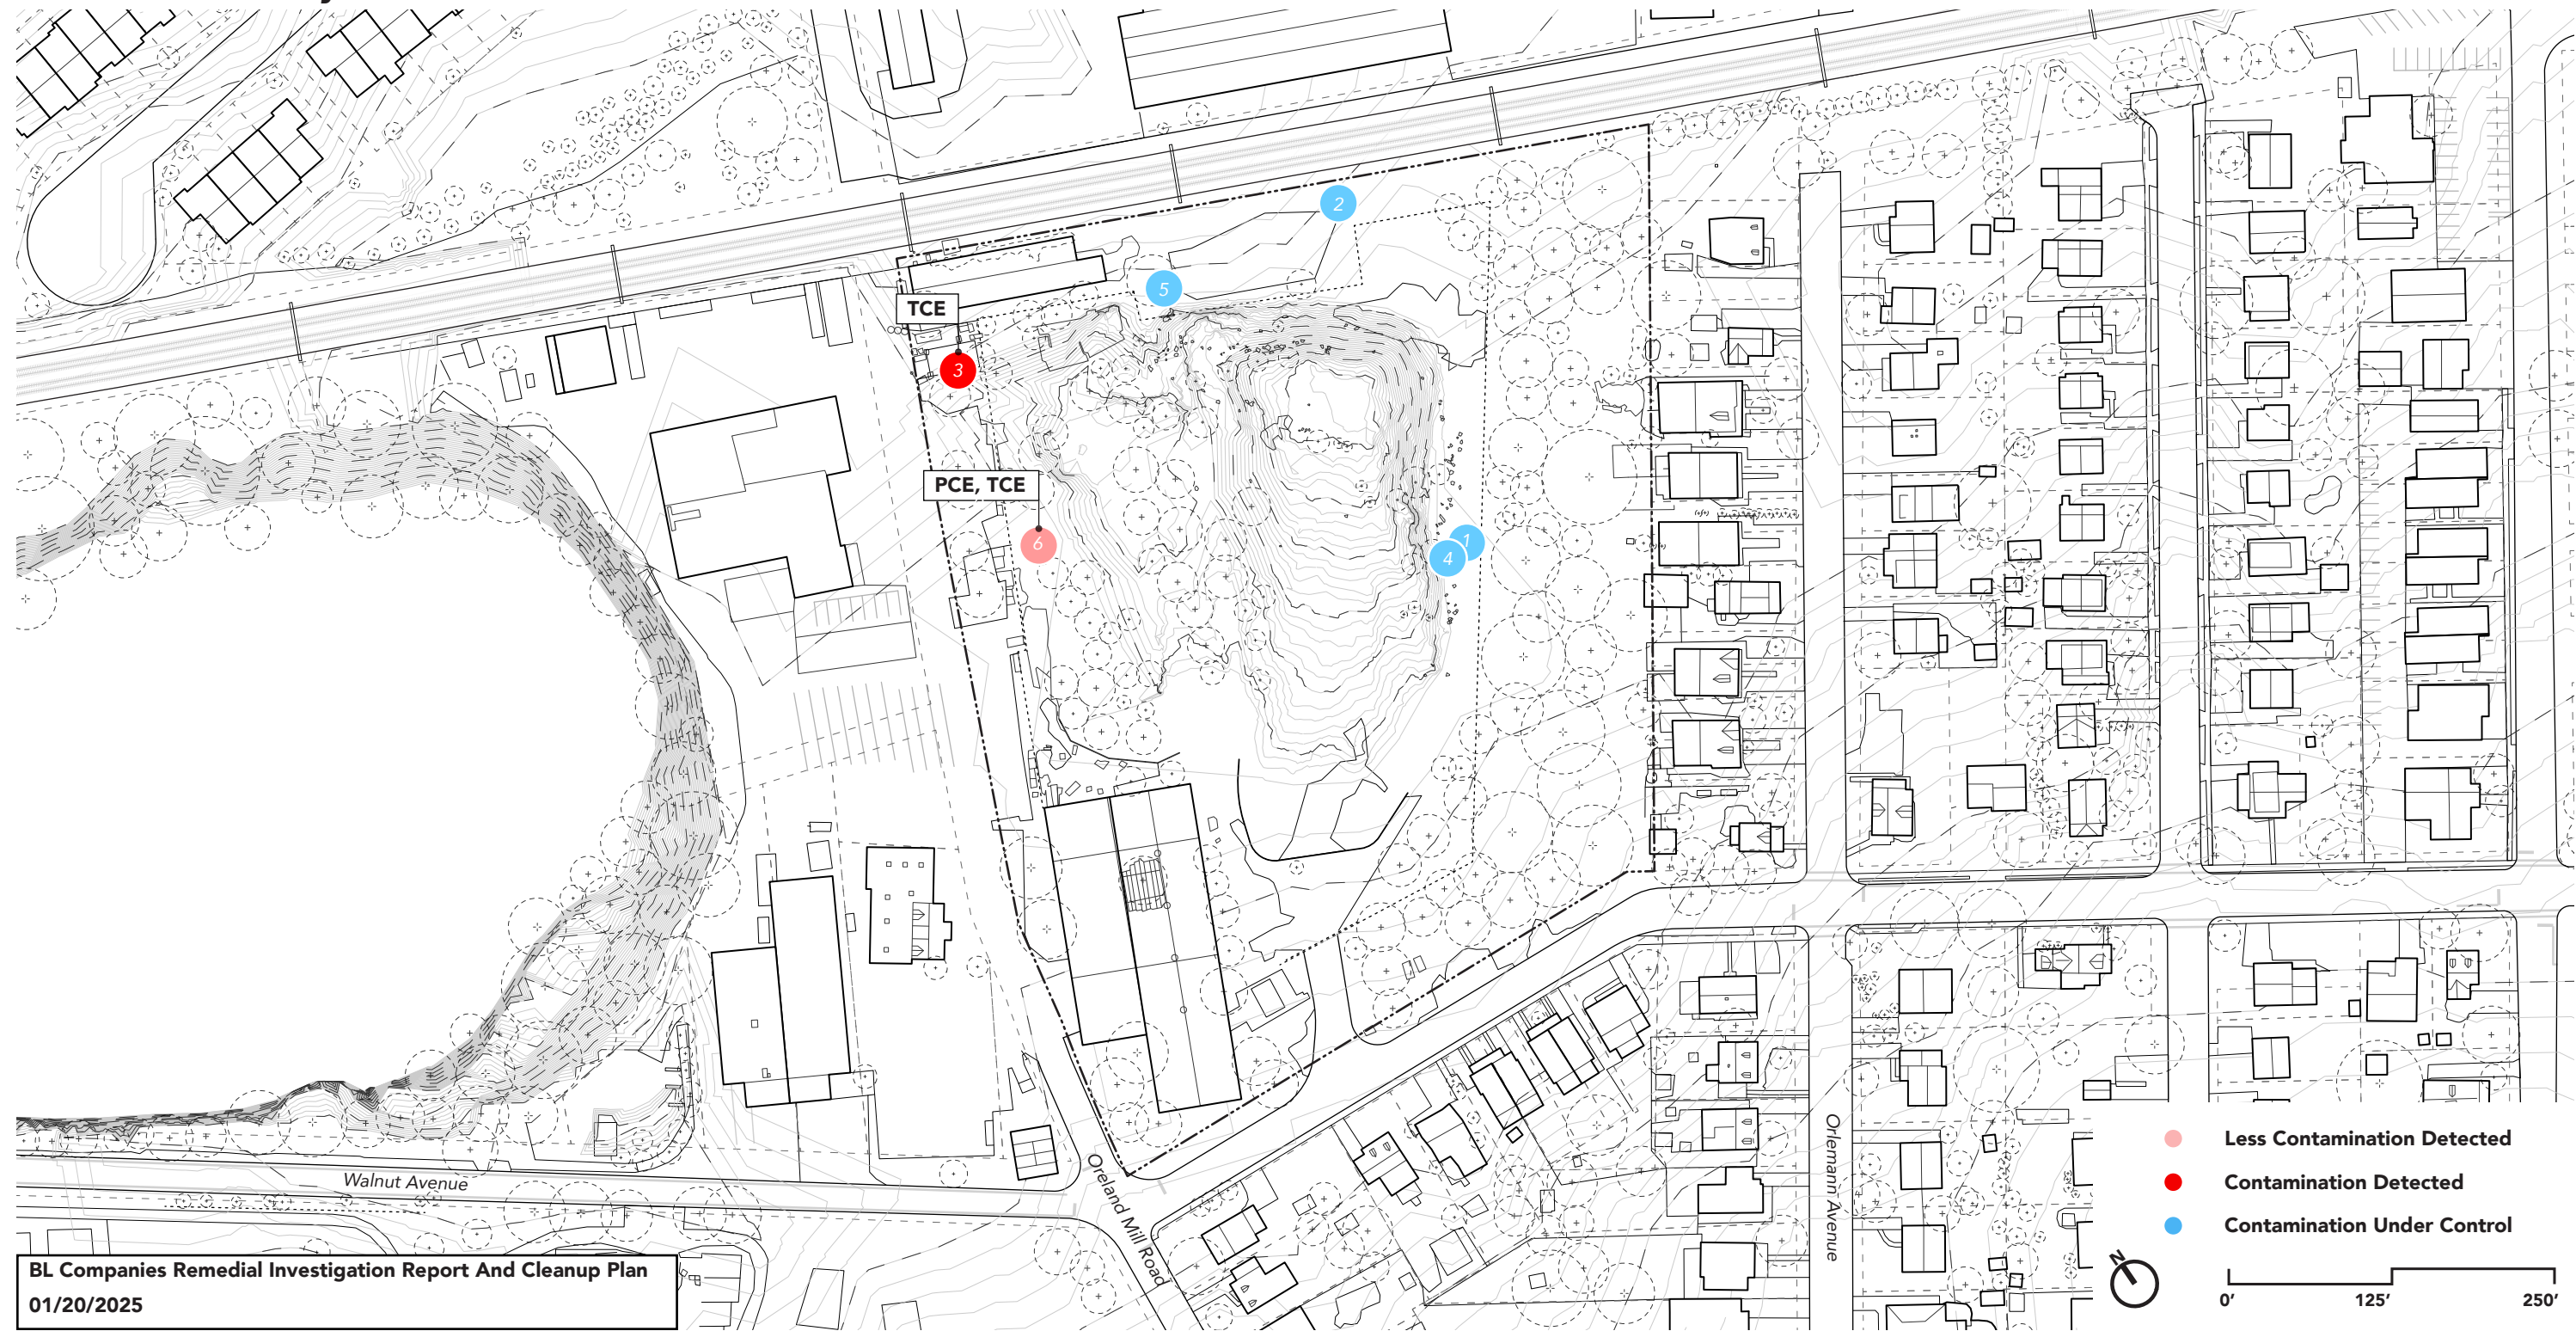
Remediation Analysis - MONITORING WELL APRIL 2018

BL Companies Remedial Investigation Report And Cleanup Plan
01/20/2025

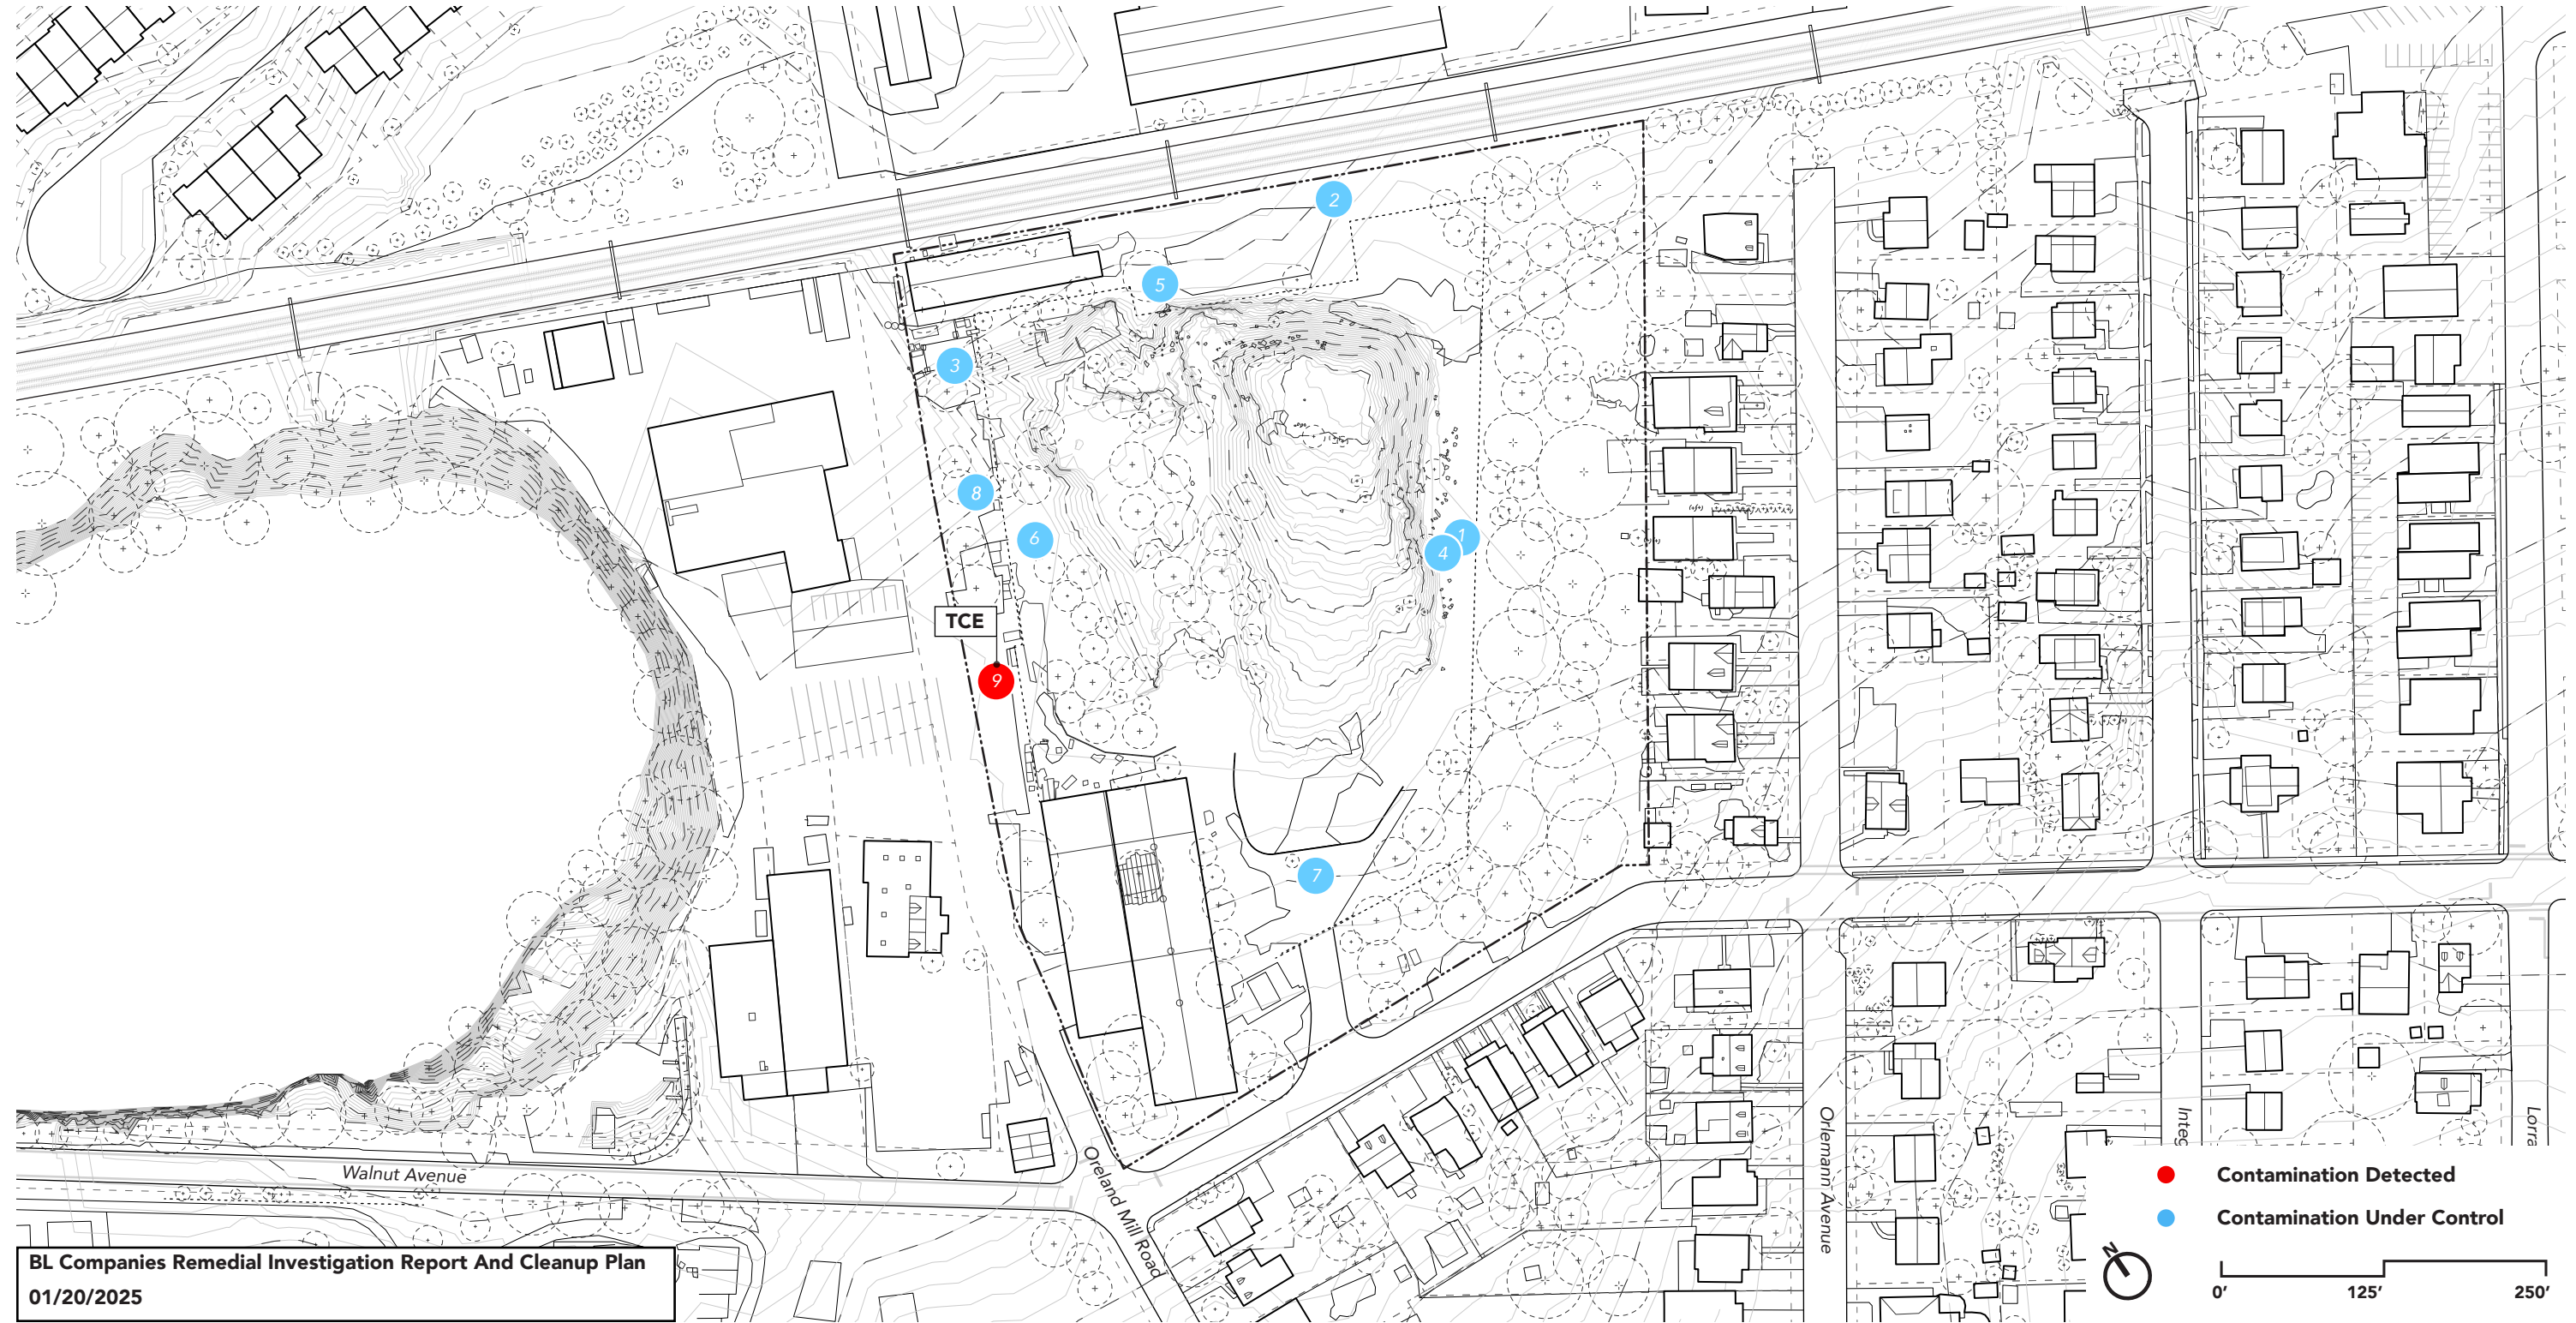
Remediation Analysis - MONITORING WELL OCTOBER 2020

BL Companies Remedial Investigation Report And Cleanup Plan
01/20/2025

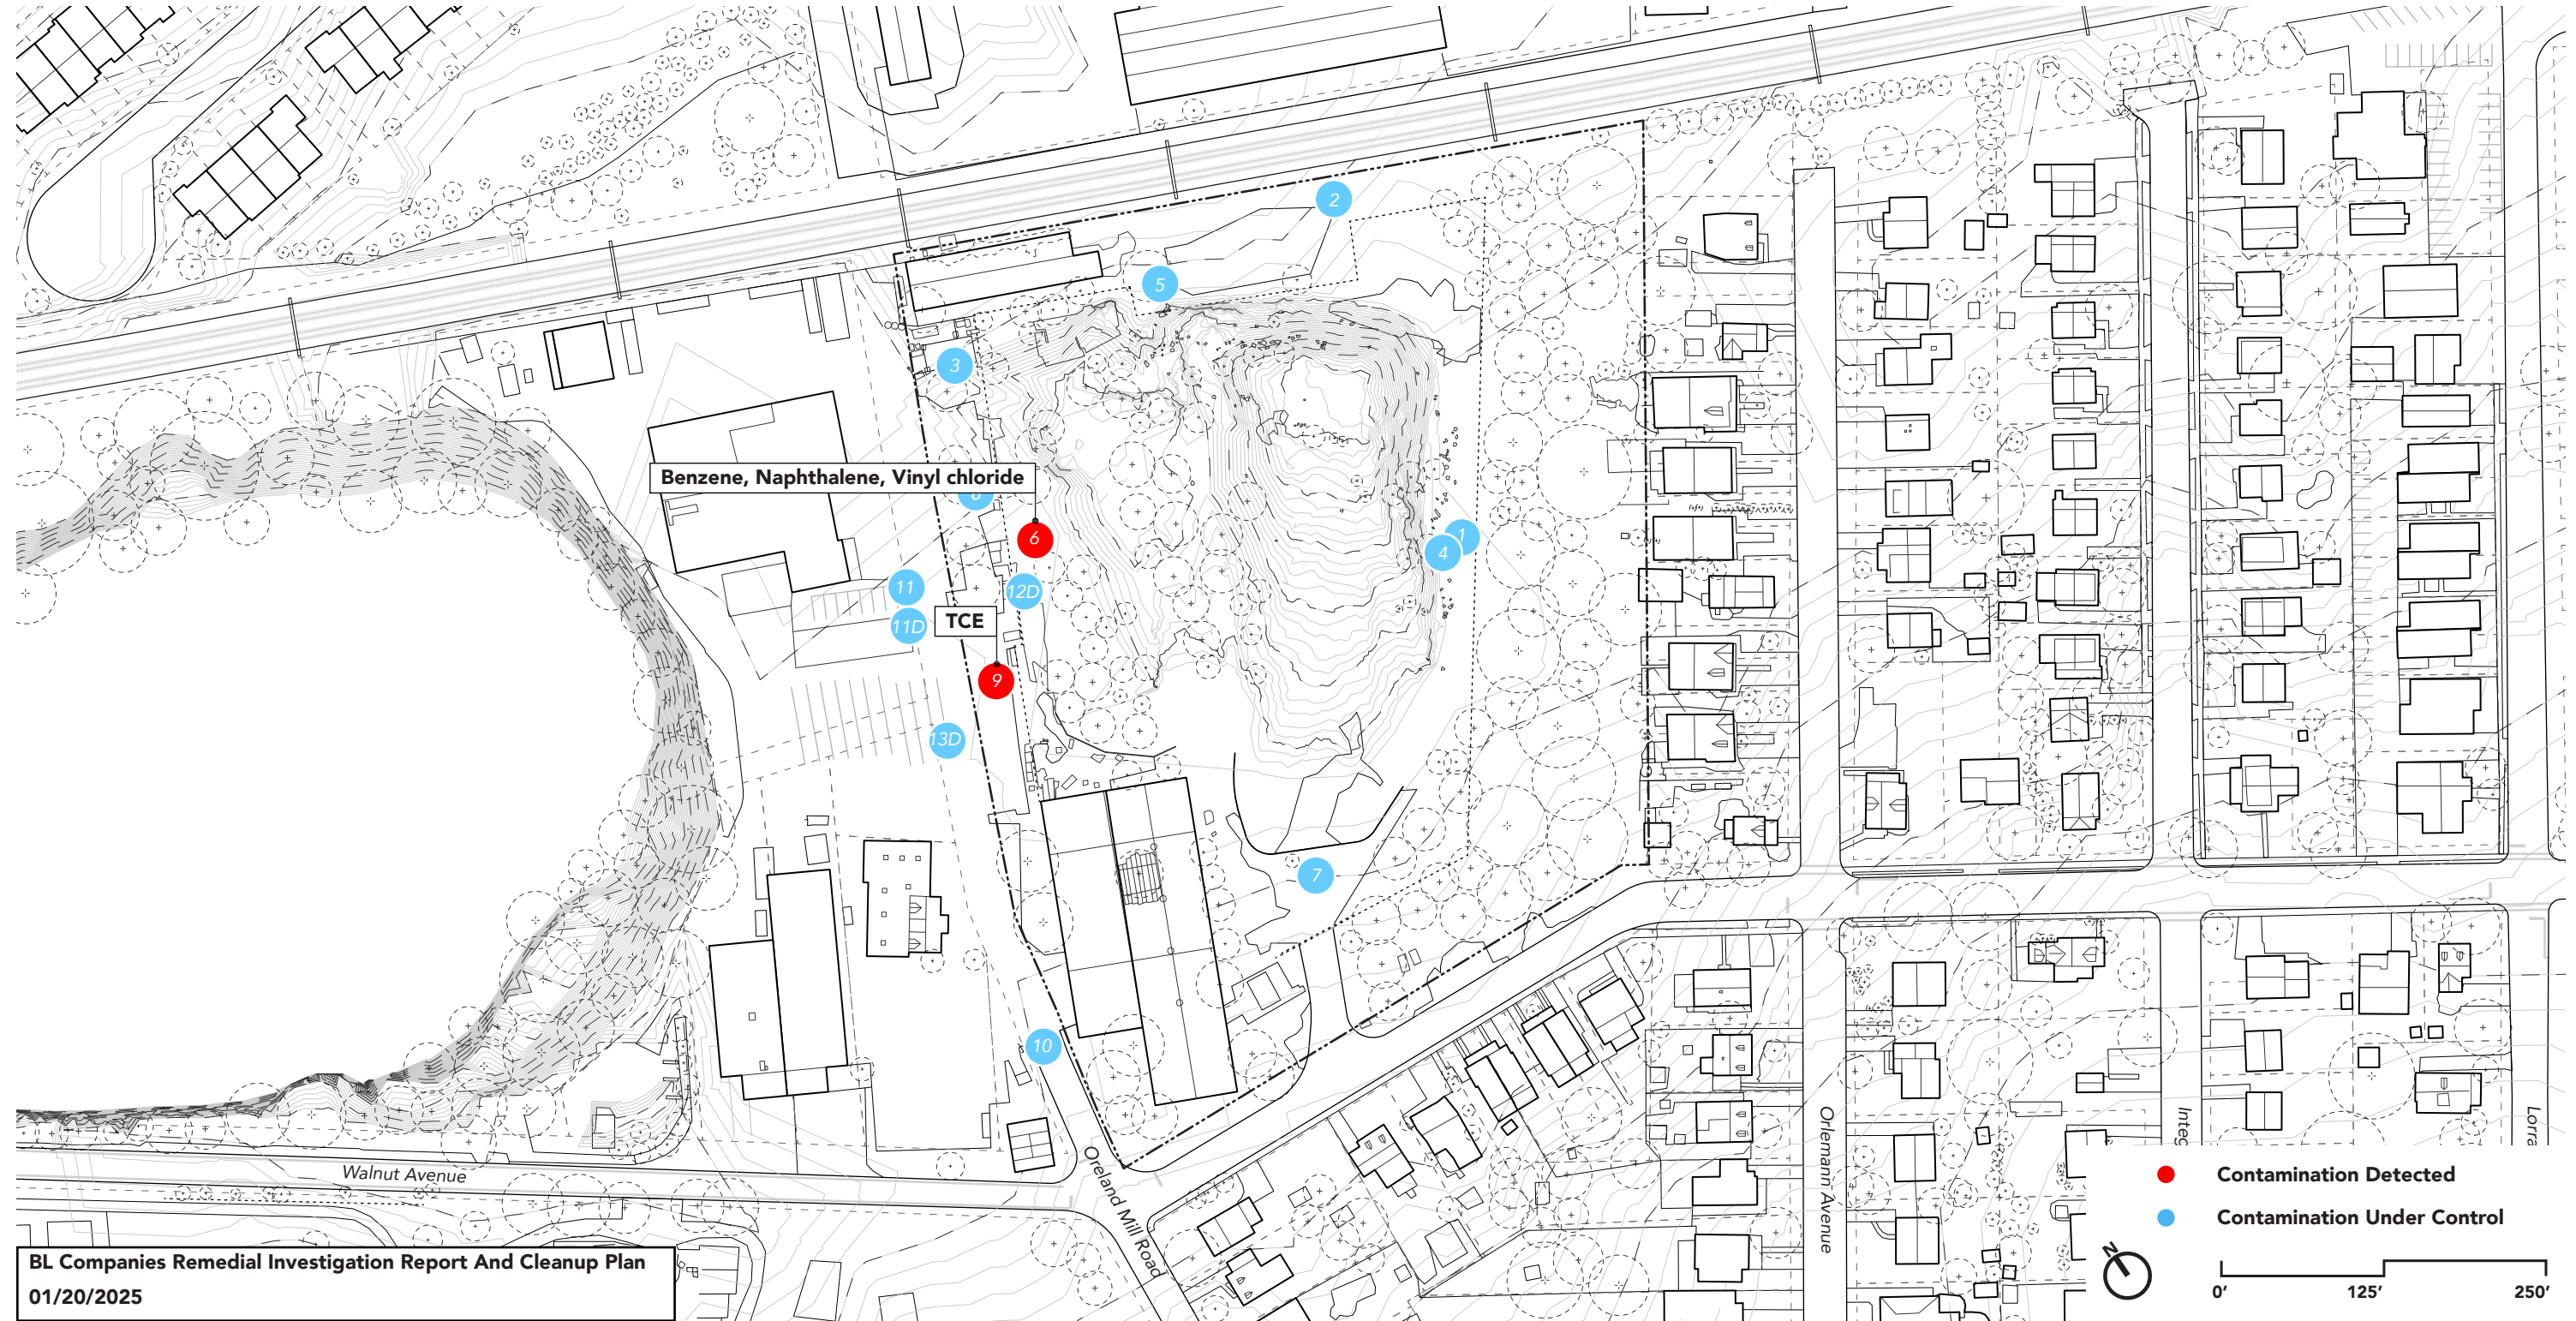
Remediation Analysis - MONITORING WELL JANUARY 2022

BL Companies Remedial Investigation Report And Cleanup Plan
01/20/2025

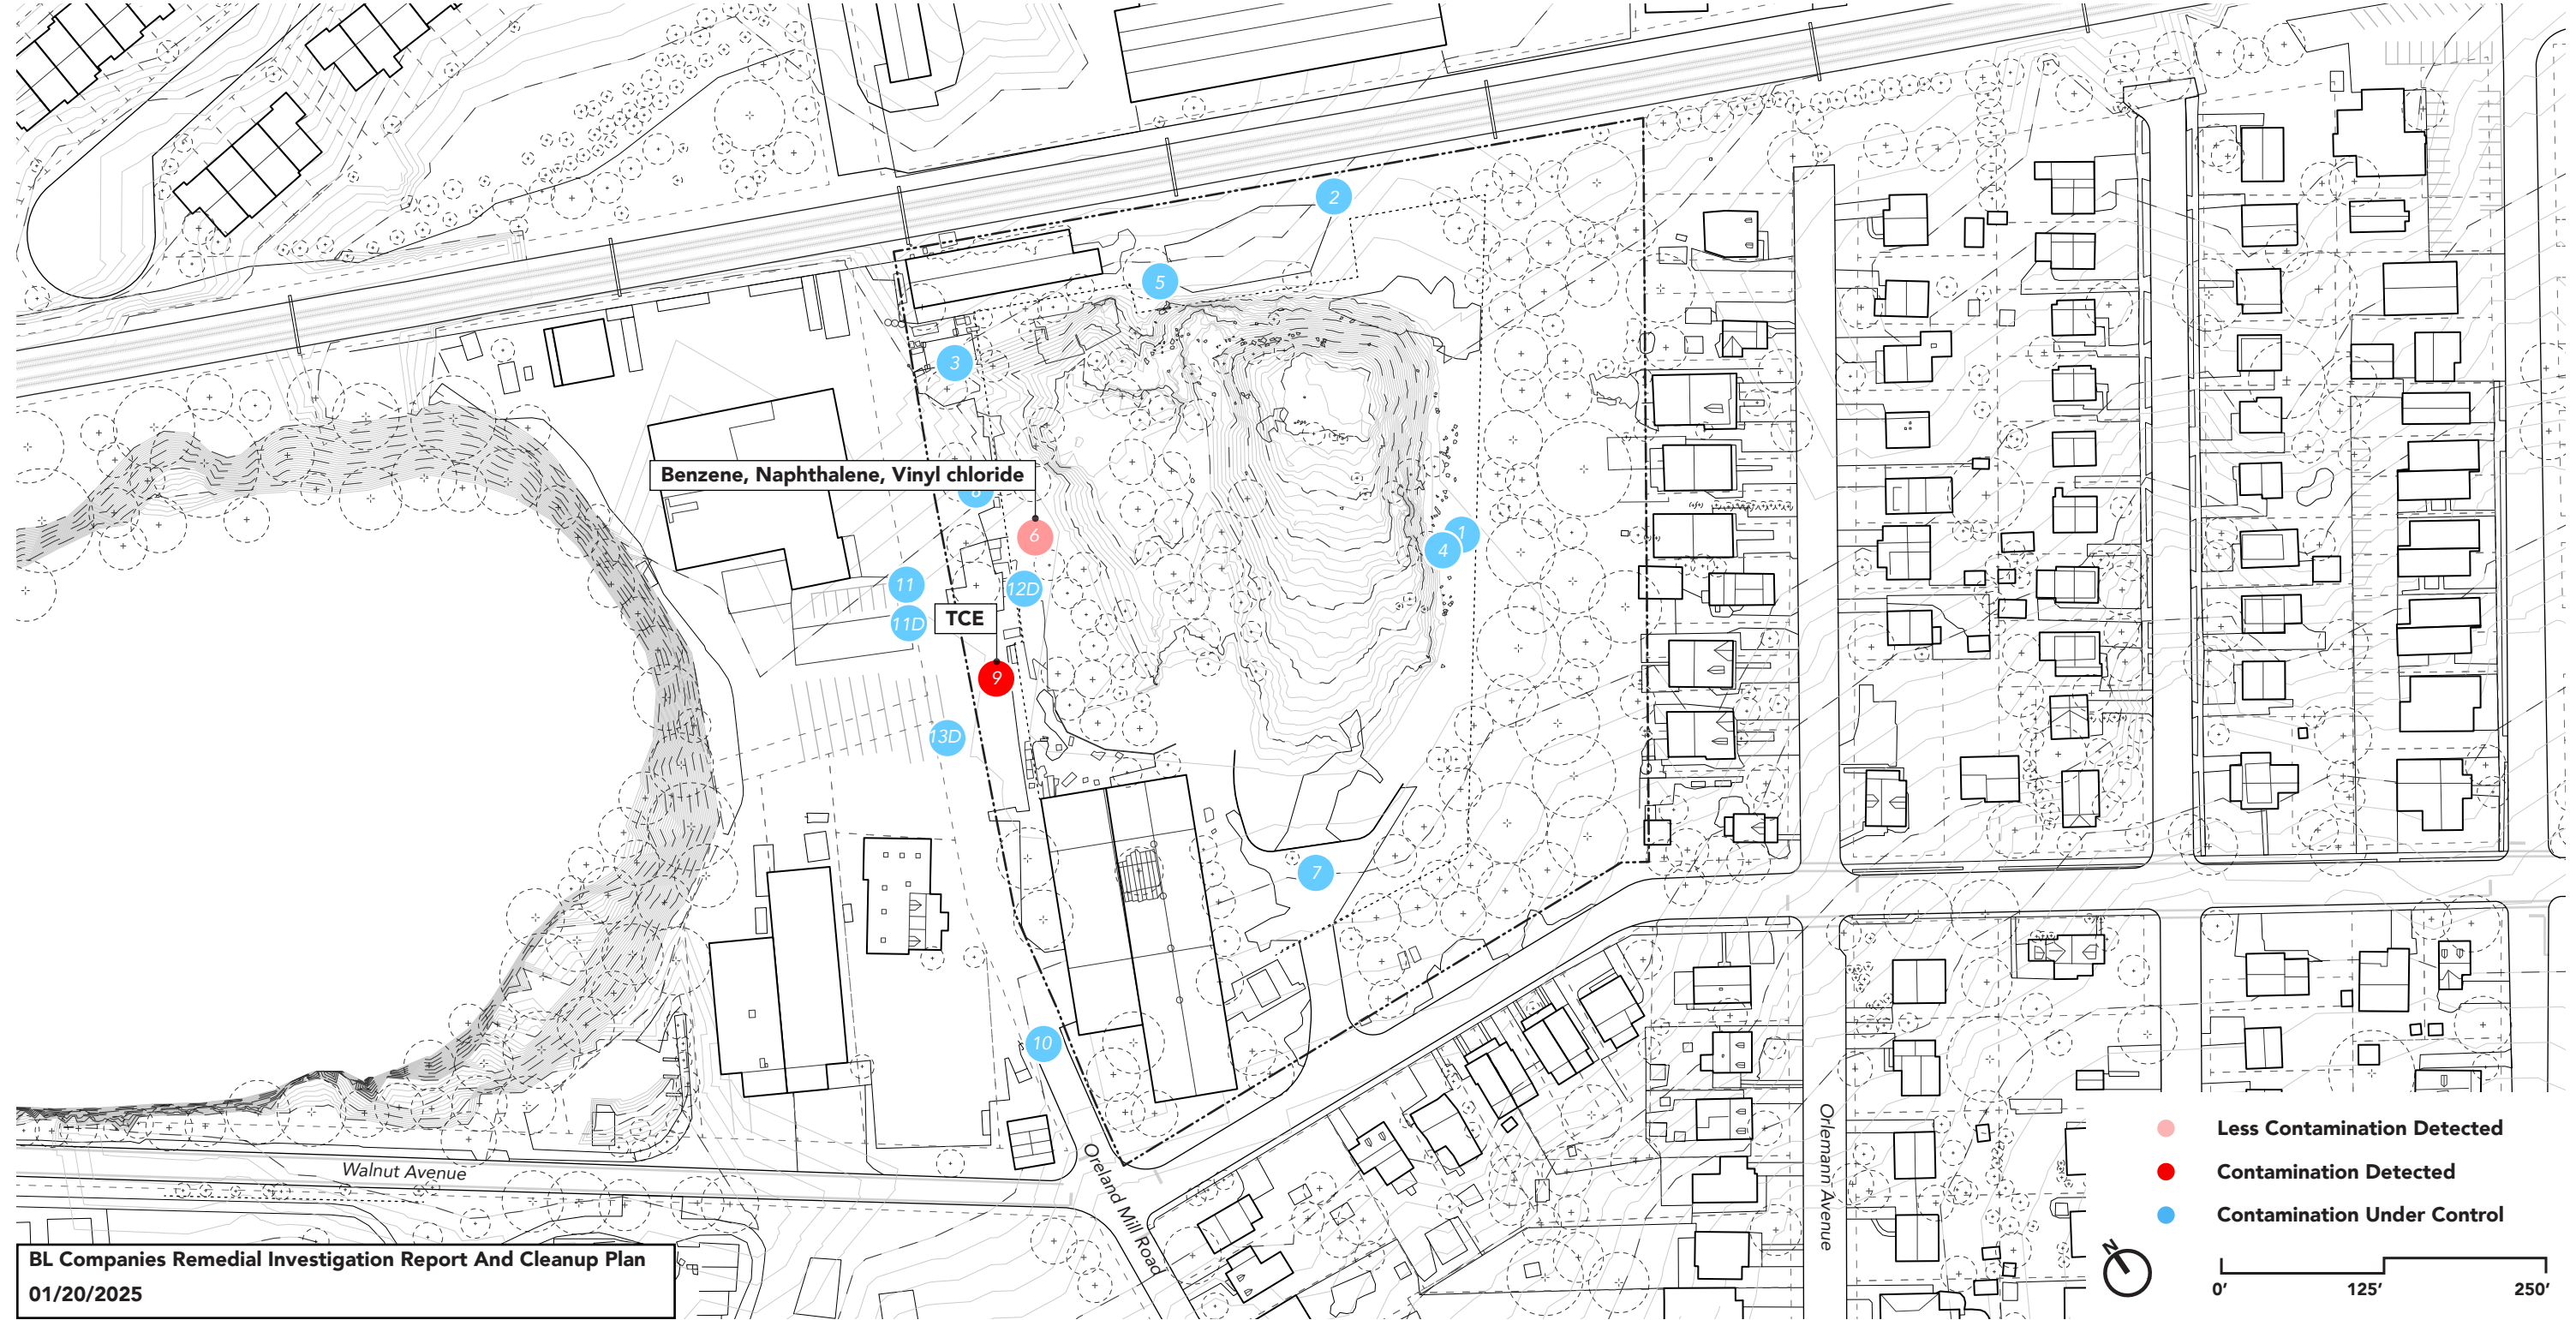
Remediation Analysis - MONITORING WELL JULY 2024

BL Companies Remedial Investigation Report And Cleanup Plan
01/20/2025

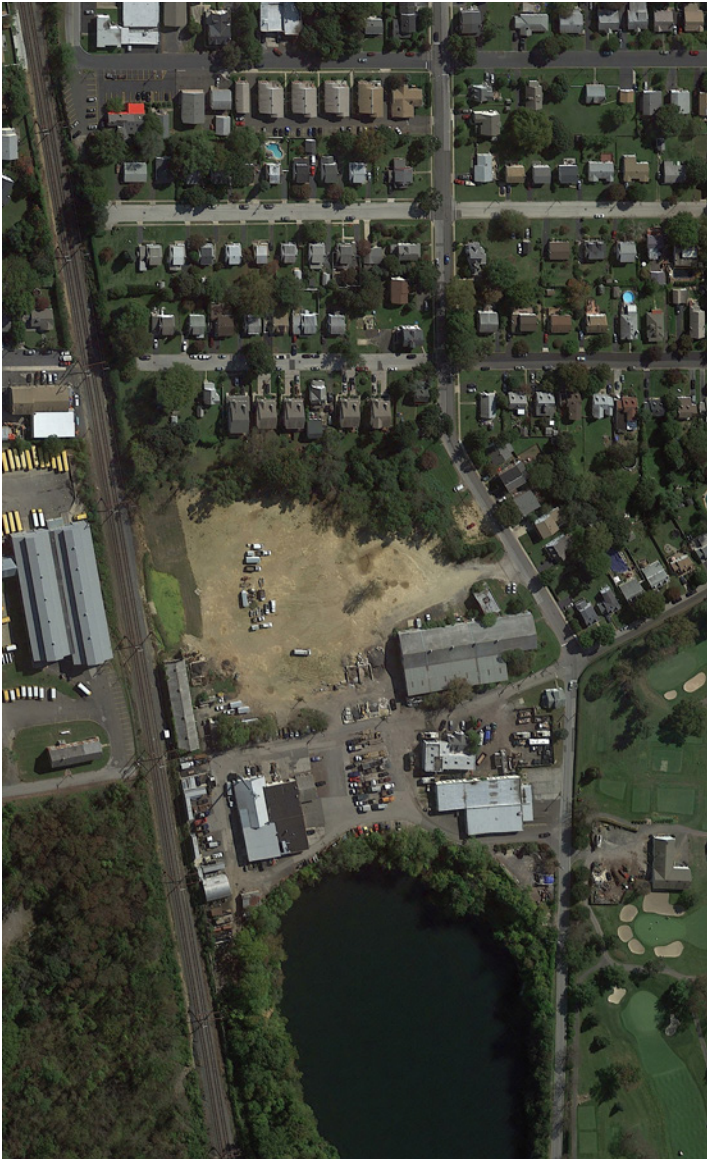
2011
Construction Phase

Ecology Analysis - SITE SUCCESSIONAL PROGRESS
